# TROUBLE SHOOTING

## PFEIFER INDUSTRIES, LLC

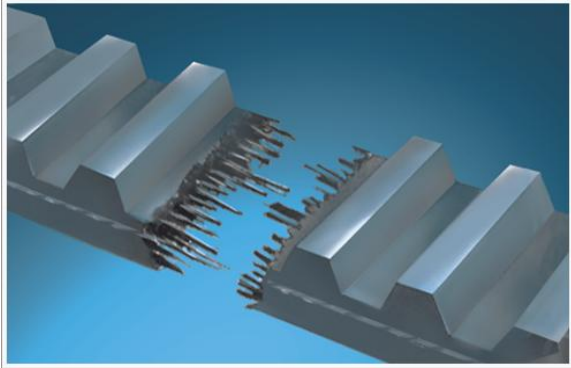
TROUBLE	CAUSE OF PROBLEM	CORRECTIVE ACTION
<b>Tensile Break</b>

Excessive shock load	<input type="checkbox"/>
	Rolling or prying the belt over the flange when installing	<input type="checkbox"/>
	Subminimal pulley diameter	<input type="checkbox"/>
	Misalignment	<input type="checkbox"/>
	Too low or high tension	<input type="checkbox"/>
	Momentary peak load exceeded design load	<input type="checkbox"/>
	Wrong belt pitch being used	<input type="checkbox"/>
	Improper belt handling and storage	<input type="checkbox"/>
	Weak support structure or mounts	<input type="checkbox"/>
	To narrow belt width	<input type="checkbox"/>
	Sharp teeth on the pulley	<input type="checkbox"/>
	Debris or foreign object in drive	<input type="checkbox"/>
	Extreme pulley run-out	<input type="checkbox"/>
	<b>Belt Cracking</b>

CORRECTIVE ACTION
Check Parallel and Angular Alignment of the Pulleys
Adjust Tension to Recommended Value
Check Horsepower Rating
Check Belt / Pulley Compatibility
Replace Pulley
Use Correct Pulley Diameter
Eliminate or Control Condition
Clean and Protect Drive
Follow Proper Installation Procedure
Follow Proper Handling and Storage Procedure
Reinstall, Replace, Repair Flange
Remount Bushing and Pulley
Change Pulley Material
Use Inside Idler
Redesign Drive
Reinforce Structure
Noise level is reduced with the use of Rubber Timing Belt
Replace Belt
Check for conductive heat transfer from prime mover
Reduce ambient drive temperature to 185°F maximum
Use Proper Width Pulley
Increase Diameter of Backside Idler
Pre-heat Drive Environment
